## CASE STUDY – 01

### Hydro generator loose rim detection

Umbrella type (Generator guide and turbine guide bearing) / Power: 205MVA; Stator Bore Diameter: 13.8m / Francis Turbine; Speed: 100 RPM

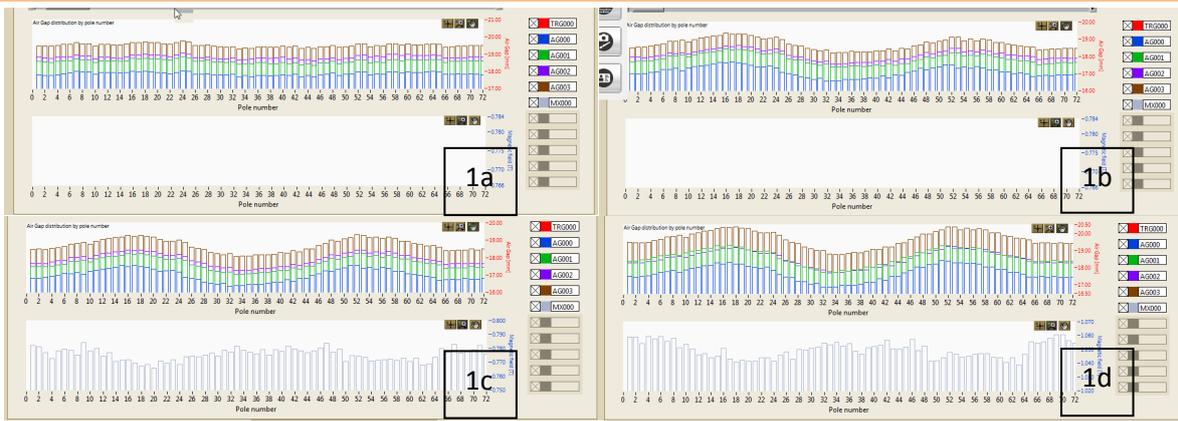
- 60% RPM free / run figure 1a; figure 2a
- 100% RPM free run / figure 1b; figure 2b
- Field flash (field increase up to 100%) / figure 1c
- Full load / figure 1d; figure 2c

The upper half of figure 1 (1a to 1d) shows the air gap pole profiles at the operating regimes listed above. The lower half shows the magnetic flux pole profile. Note that when the generator is at free run (figure 1a and 1b) it is unexcited and there is no field, thus the magnetic flux pole profile is empty..

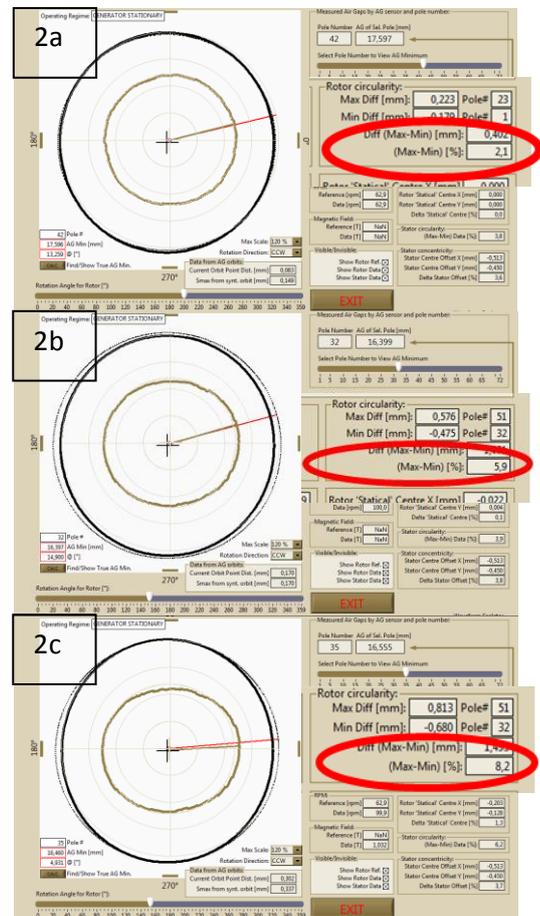
**The stator and rotor shape comparison is shown on figure 2**

Figures 2a to 2c shows that the rotor stiffness and shape are not consistent at the various operating regimes

**Rotor circularity offset was changing as follows:**

**2.1% @ 60% RPM/no excitation** – no high centrifugal forces

**5.9 % @ 100 RPM / no excitation** - the centrifugal forces started to stretch the rim. The rim distortion due to stretch is more apparent in one direction than the other. The major axis of the ellipse was in the direction of poles 32 to 68 and the small axis was in the direction of poles 15 to 51.

**8.2% @ full load** - both centrifugal and magnetic forces are present. Additional distortion was visible in the same direction (poles 32 to 68) at full load and the rim stiffness continued to decrease in that direction.

Following industry guidelines [1] adapted for dynamic measurements the tolerances for rotor circularity should not exceed 6%. This Unit at full load steady state was 8.2%, and outside of this guideline

The end user organized the rim to be inspected by the OEM and the conclusion was for the rotor to be re-shrunk in order to achieve adequate rotor rim stiffness and ensure stable and safe operation of the unit.
