## CASE STUDY – 02

### Hydrogenerator loose stator core

#### Problem: Detected Loose Stator core

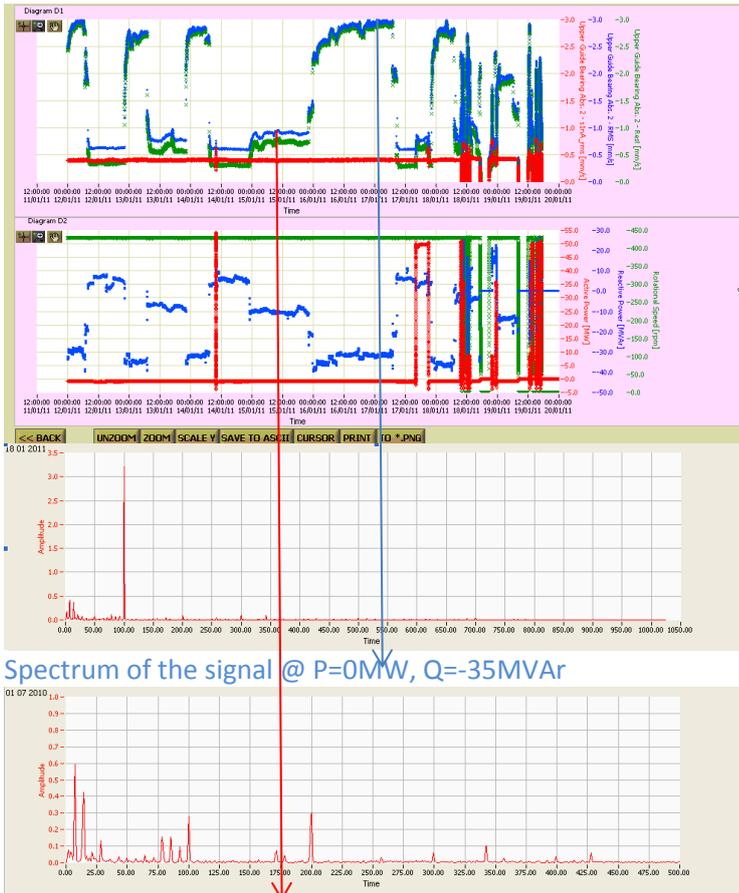
Data recorded in January 2011 revealed the problem with high vibration at the mentioned sensor position. Historical trends were analysed as shown in figure 1. The vibration data was analysed alongside operating parameters such as RPM, P (Active Power) and Q (Reactive Power). Comparison of data in different operating conditions is crucial in understanding machine behaviour. It was clear that vibrations on that bearing were changing significantly with operating conditions, most significantly with reactive power.

Trend results of 10 days on UGB 18.01.2011,  
**RMS (overall) = 3 mm/s/**  
**Rest value = 2.8 mm/s /**

1st has not changed  
*Rest = RMS – 1st, 2nd and 3rd harmonic*  
**Upper diagram:** RMS value (blue curve), S1n value (red curve),

Rest value (green curve)

**Lower diagram:** Red curve – Active Power; Blue Curve – reactive power

Green curve – RPM

From 100 Hz component in the spectrum on UGB, the conclusion of Veski experts was that vibration problems occurred due to the fact that the *stator core was loose* and that *the problem was not in the bearing itself*. This was seen from the absolute vibration sensor located at the upper guide bearing and is very visible when the machine operates in capacitive load with more than -20 Mvar.

When the core stiffness decreases the natural frequency of the core decreases into the 100 Hz zone and this resonance causes the vibration amplitudes to increase. The driving force also changes with the operating conditions and as it increases it causes the core to vibrate at higher amplitudes at 100 Hz frequency. The core vibrations are transferred to bearing housing causing the bearing vibrations at 100 Hz but lower in amplitudes than on the core.

The machine was stopped and the core problem was repaired in the shortest possible timeframe putting this important machine at full availability.
