CASE STUDY – 07

Loose bearing to foundation support / Portable Diagnostic System

Steam turbine generator / Power: 35 MW; 3000 RPM

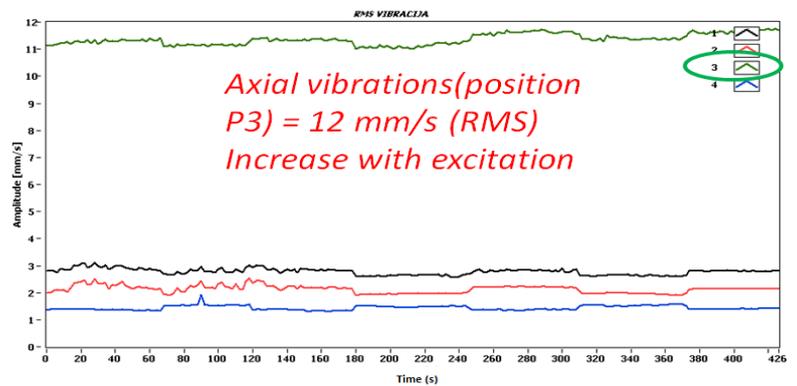
Problem: High vibration on generator bearing in axial direction

Vibration measurements were conducted before a scheduled overhaul on the generator and turbine bearings. Vibration amplitudes were in tolerance in the radial direction but the absolute vibration was considered very high in the axial direction on one of the generator bearing housings. The high vibration amplitudes occurred with excitation and increased with load.

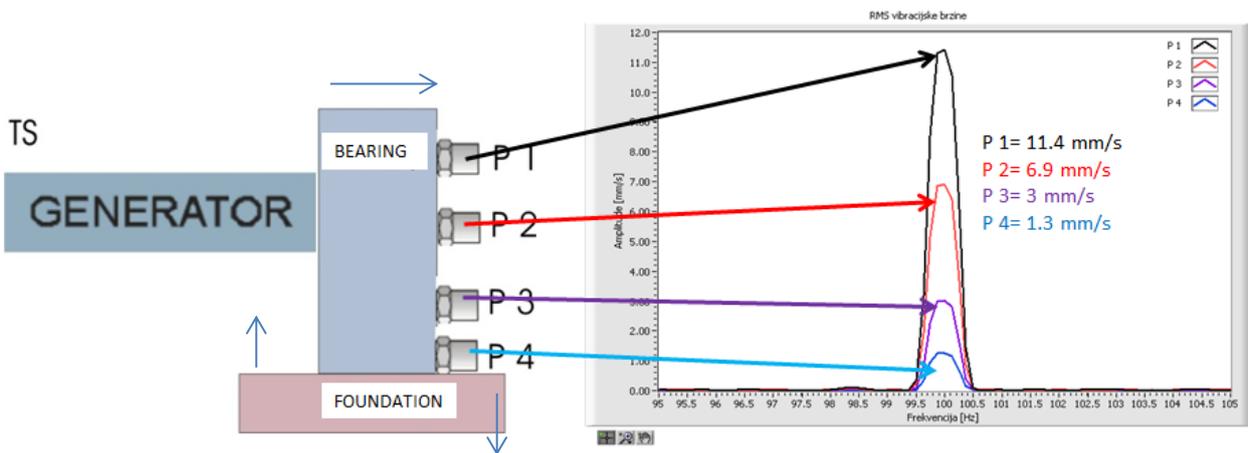
Using CoDiS-PDS¹, relevant vibration data was captured and analysed. Since high axial vibrations occurred with excitation, resonance was suspected near the 100 Hz frequency causing the bearing vibration levels to amplify as a result of exciting a critical frequency.
