CASE STUDY – 07

Loose bearing to foundation support / Portable Diagnostic System

Steam turbine generator / Power: 35 MW; 3000 RPM

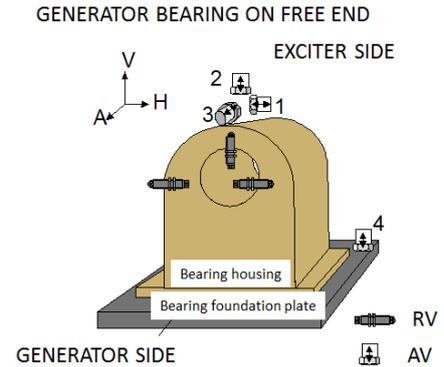
Problem: High vibration on generator bearing in axial direction

Vibration measurements were conducted before a scheduled overhaul on the generator and turbine bearings. Vibration amplitudes were in tolerance in the radial direction but the absolute vibration was considered very high in the axial direction on one of the generator bearing housings. The high vibration amplitudes occurred with excitation and increased with load.
